Paper **03214**

CORROSION2003

CORROSION MECHANISMS OF UNS N04400 IN SEA WATER

Jason S. Lee, Kristine L. Lowe, Richard I. Ray, and Brenda J. Little Naval Research Laboratory / Code 7303 and 7330 Stennis Space Center, MS 39529-5004

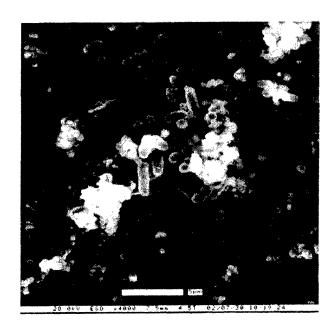
Figure 3a: Base metal with patchy distribution of SRB after 12 weeks exposure to ASW + SRB.

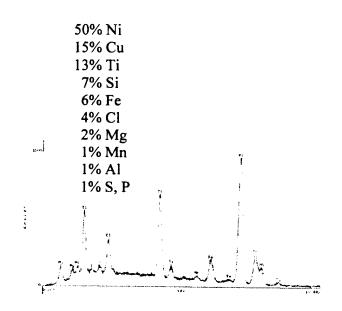
Figure 4d: EDS of weld filler with dealloying under layer after 12 weeks exposure to ASW + SRB.

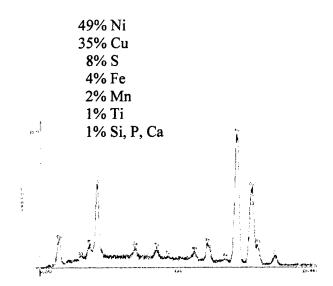
Figure 5b: EDS of SRB and corrosion layer covering base metal after 14 weeks exposure to ASW + SRB.

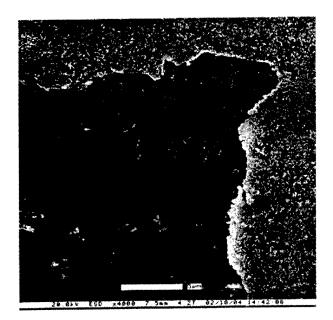
Figure 5c: Pit in base metal revealed after acid cleaning and 14 weeks exposure to ASW + SRB.

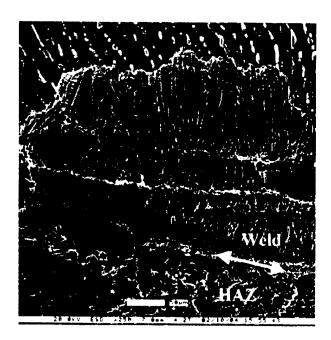
Figure 6a: Pitting and undercutting at weld filler/HAZ interface revealed after acid cleaning and 14 weeks exposure to ASW + SRB.

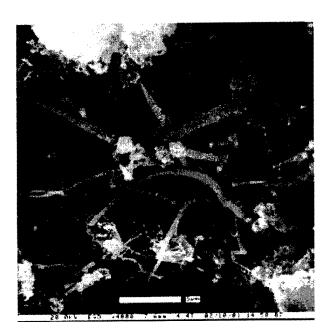
Figure 7c: Base metal with sulfide encrusted SRB after 16 weeks exposure to ASW + SRB.

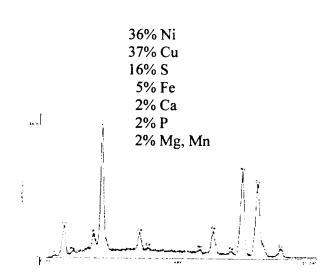
Figure 8d: EDS of base metal covered with sulfide encrusted SRB and associated with black sulfur-rich layer after 20 weeks exposure to ASW + SRB (before cleaning).
